CHAPTER 42

FLIXBOROUGH: THE DISASTER AND ITS AFTERMATH

J. E. S. Venart

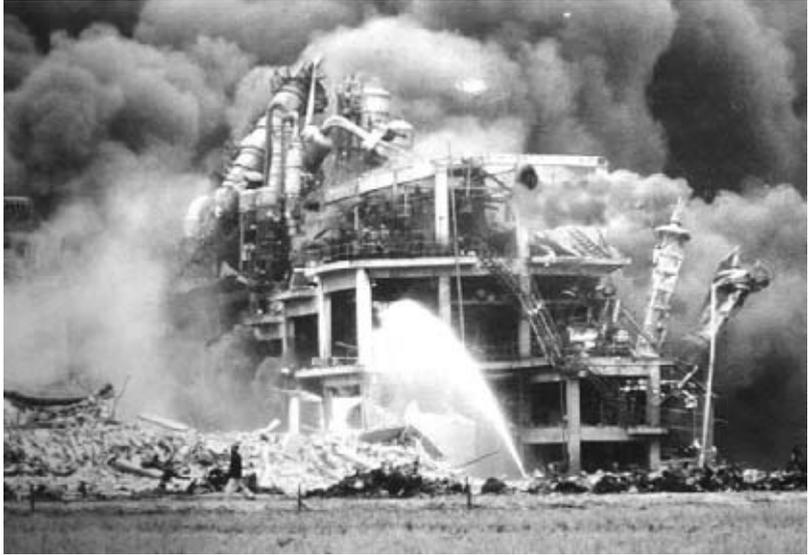
FIGURE 42.6 Looking north over the rubble of the main office building into section 27. (Photograph courtesy the Scunthorpe Evening Telegraph.)

The scale of the disaster and damage can be appreciated from photographs taken soon after the explosion and shown in Figs. 42.6 and 42.7.

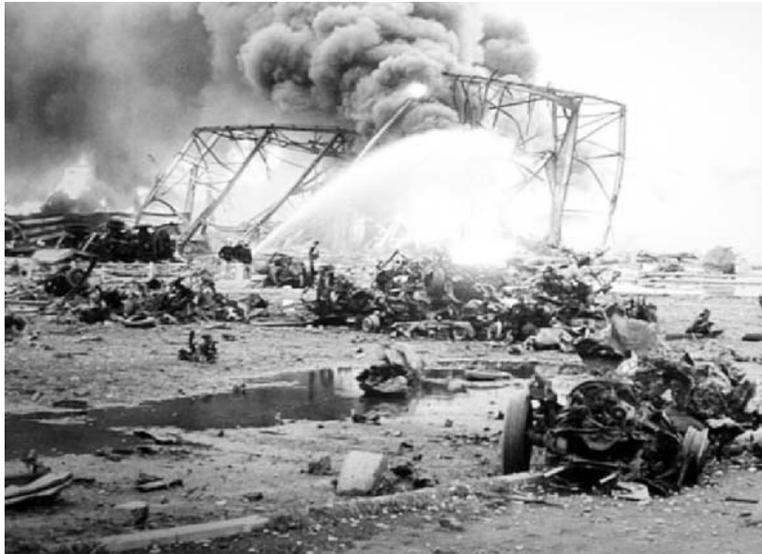
FIGURE 42.7 The Nypro parking lot to the southeast of the main office building. (Photograph courtesy of the Scunthorpe Evening Telegraph.)
